Abundant Life Christian Center
Waters of the U.S. Delineation Report
Bay Minette, Baldwin County, Alabama

February 2, 2024

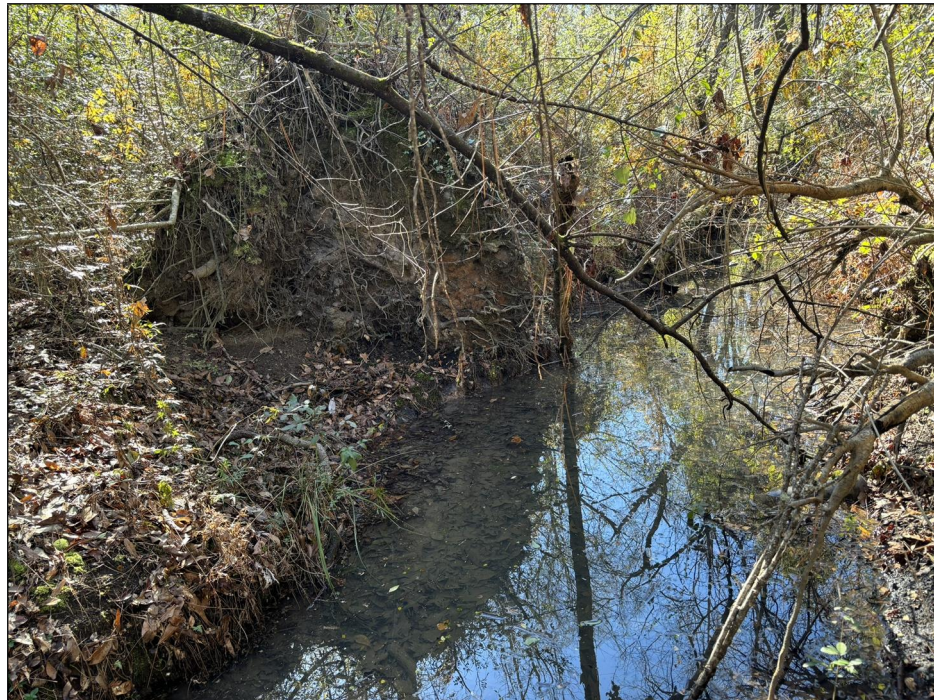
On the day of the site visit, two (2) drainage ditches (D-1 and D-2) were identified on the subject property. D-1 and D-2 are man-made dug ditches. D-1 is situated at the property’s southwest corner, extending along the southern boundary, before its confluence with D-2. D-2 is located in northern portion of the site and extends south through the central portion of the property. See Appendix A for figures depicting the location of the ditches. The table below shows the linear footage of each ditch. General photographs of the ditches are attached in Appendix B.

General view of D-2.

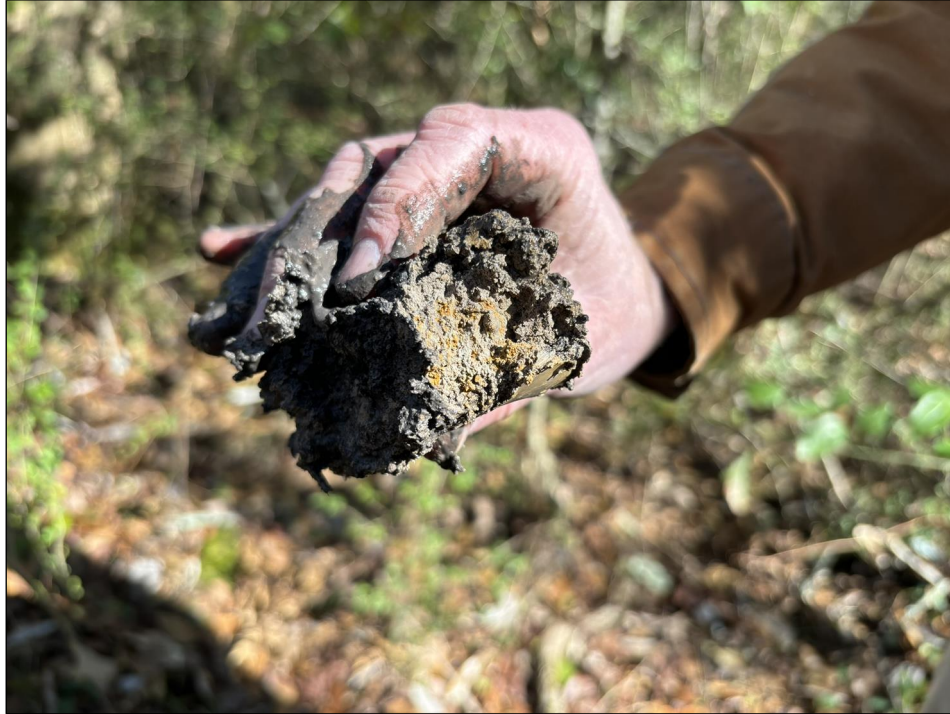
Soil samples were observed throughout the subject site and hydric soils were identified within W-1. A hydric soil is one that is saturated, flooded, or ponded long enough during the growing season to develop anaerobic conditions in the upper horizons. Redox features within the soil matrix and pore lining were noted throughout W-1. According to the Baldwin County Soil Survey, the project area contains two (2) soil types: Malbis fine sandy loam, 0 to 2 percent slopes and Grady soils. A list of the following soil types is described below.

View of reduced iron and depleted matrix located within W-1.

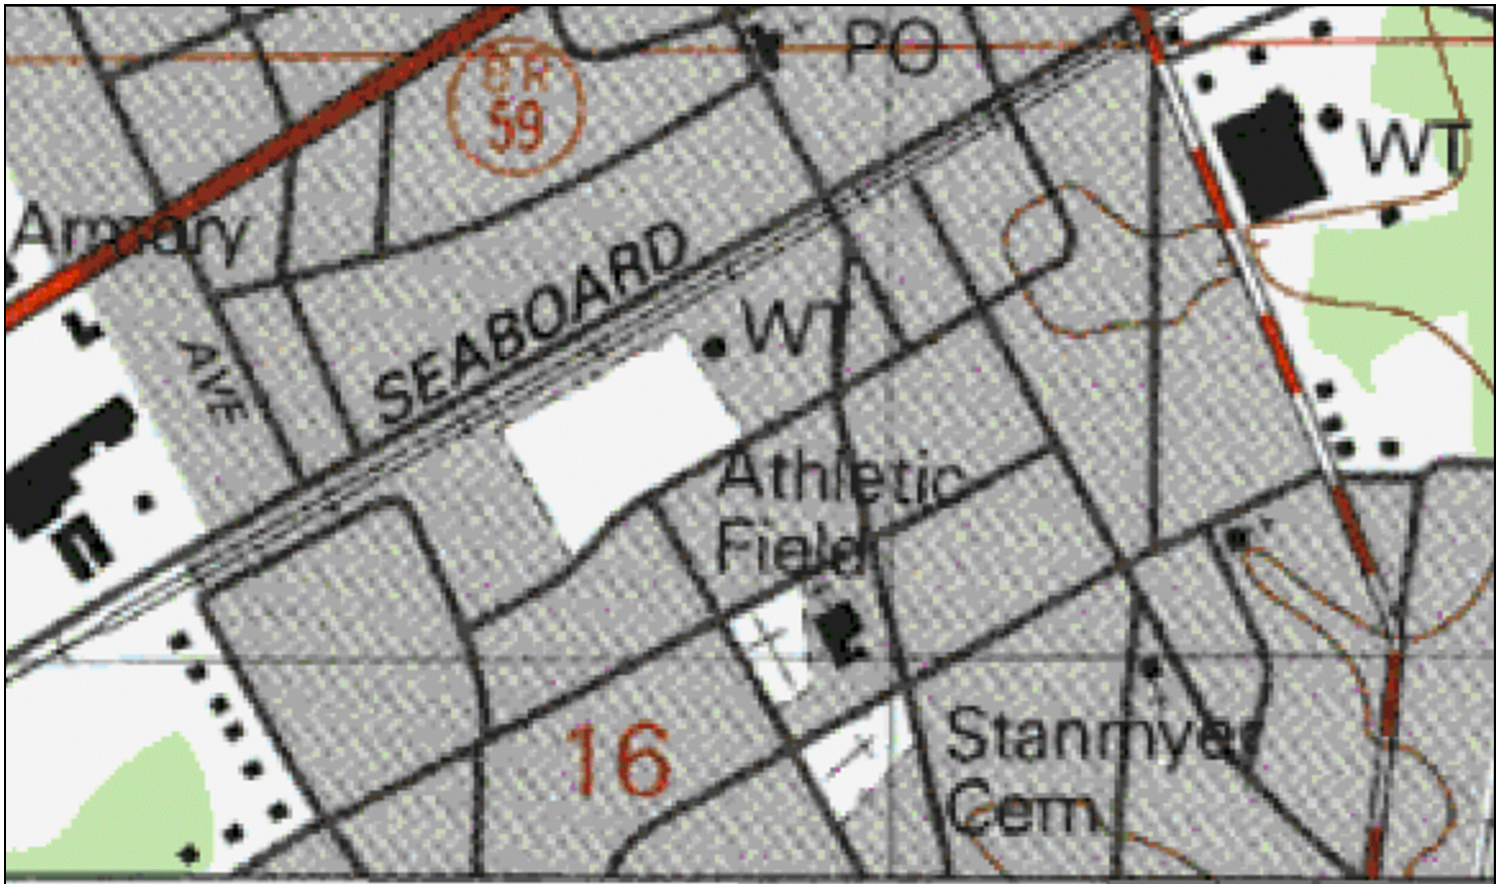
FIGURE 3

The subject site was found on the 1980 Photorevised 1985 Bay Minette, Alabama, U.S. Geological Survey Quadrangle map. The subject site ranges in elevation from approximately 75-80 feet above mean sea level. Wetland hydrology indicators observed on site include presence of reduced iron, saturation, high water table, and crayfish burrows.

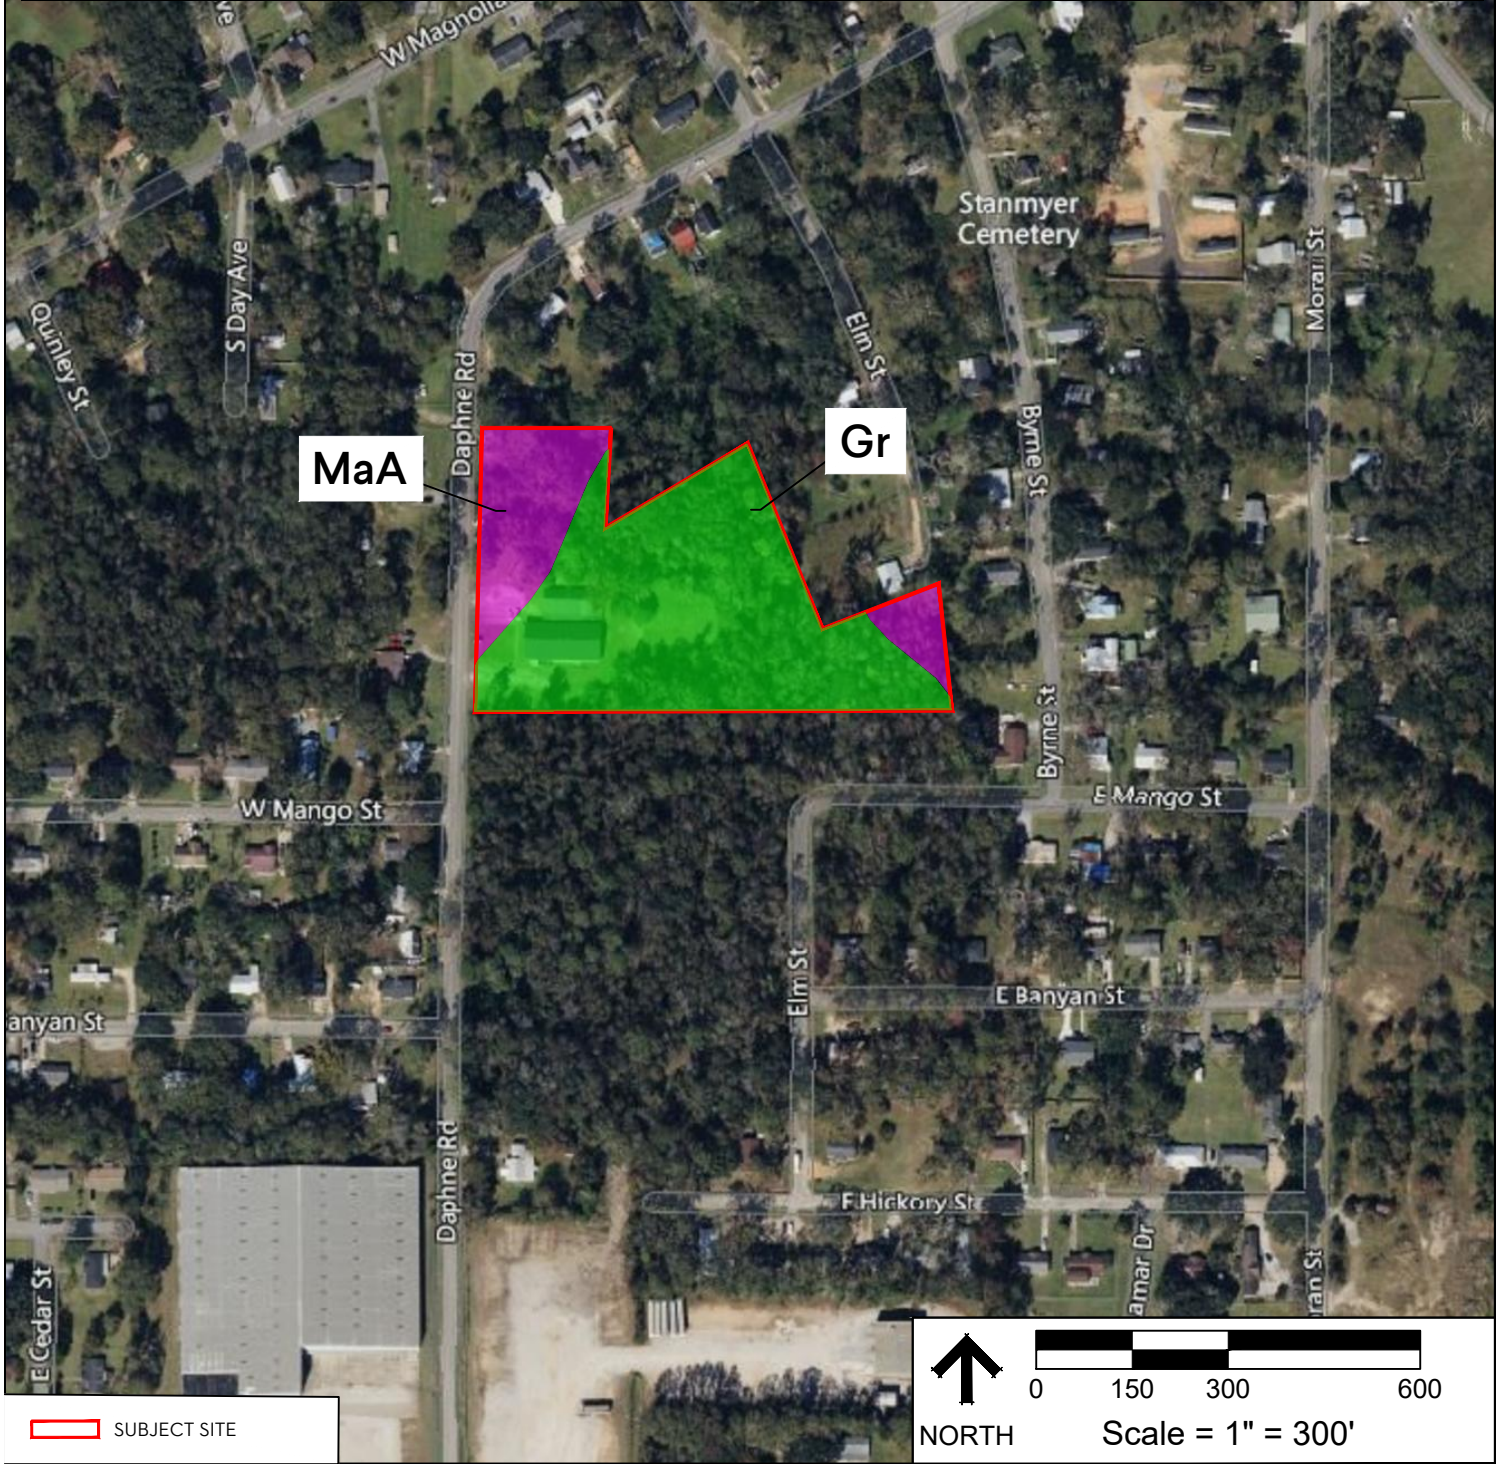
FIGURE 4

Prior to visiting the site, GMC biologists reviewed available maps including aerial photography (historical and current), USGS quadrangle, Baldwin County Soil Survey, National Wetland Inventory (NWI) map, and Federal Emergency Management (FEMA) maps in order to determine the potential for waters of the U.S. at the site. The 2023 aerial imagery depicts a building and maintained field in the southwest corner and a hardwood forested area throughout the rest of the site (Figure 2). The Bay Minette, Alabama USGS Quadrangle Map (Figure 3) and NWI Map (Figure 5) depict no wetlands or streams throughout the property. A review of the FEMA flood map revealed that the property is located outside of the Special Flood Hazard Area (SFHA) within Zone X (Figure 6). According to the Baldwin County Soil Survey, the project area contains one (1) soil with a hydric component: Grady soils. These soils have a hydric rating of 85 which indicates that 85% of the mapped soil components meet the criteria of a hydric soil. The Gr soil is located throughout the central portion of the site.

Map Unit Symbol	Map Unit Name
Gr	Grady soils
MaA	Malbis fine sandy loam, 0 to 2 percent slopes

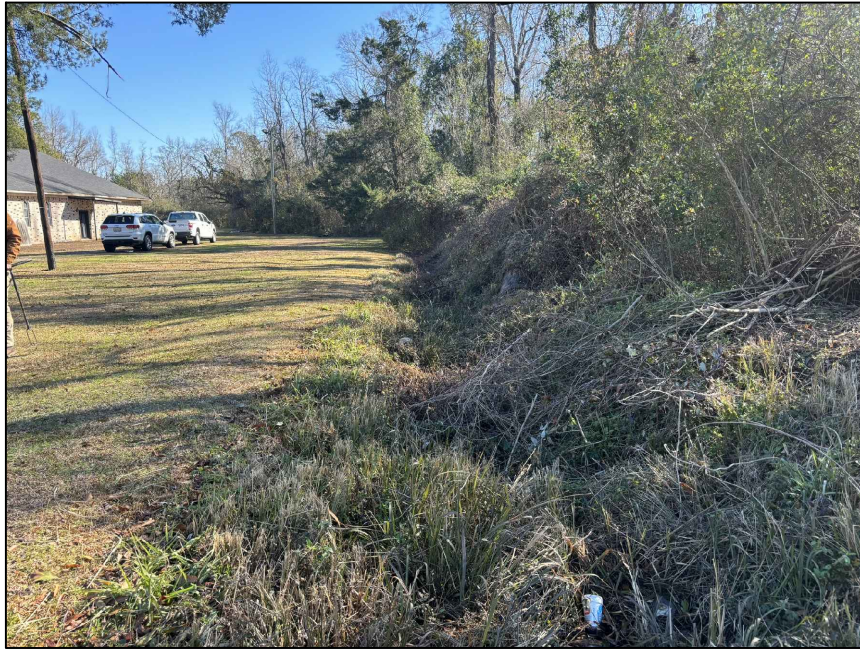
P-3

General view of D-1 located in the southwest corner of the site, extending east.

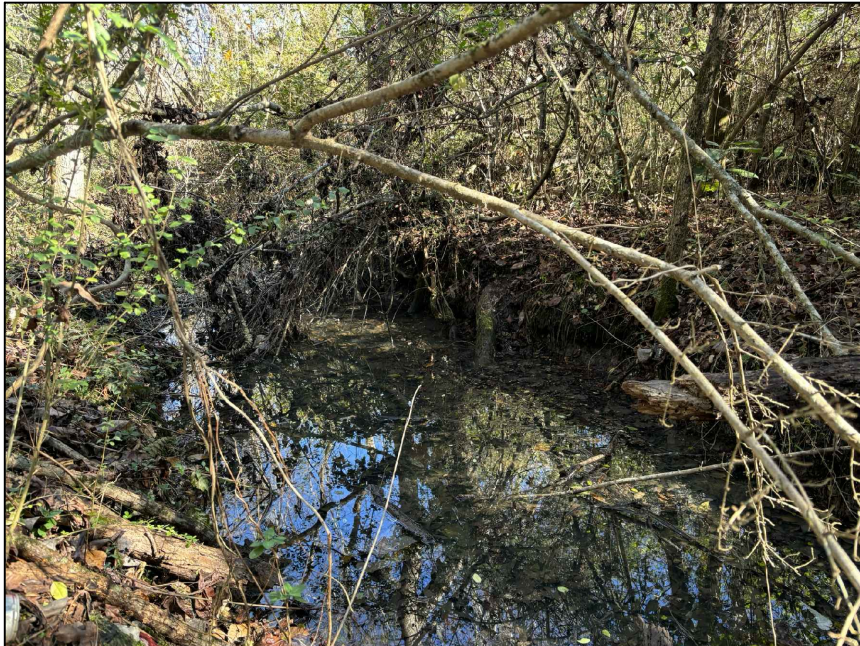
P-4

General view of D-2 located in the central portion of the site, extending north.

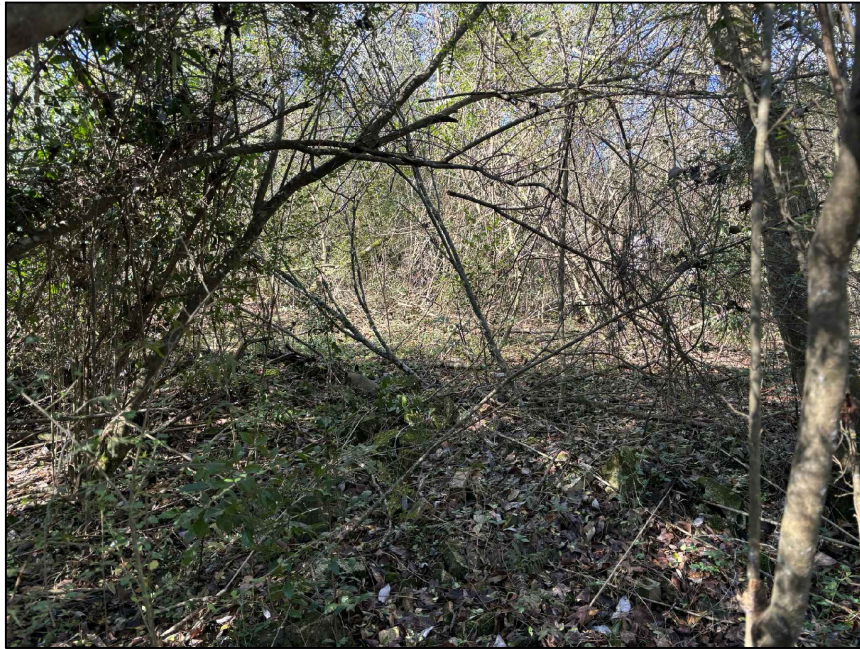
P-5

General view of the southern portion of W-1.

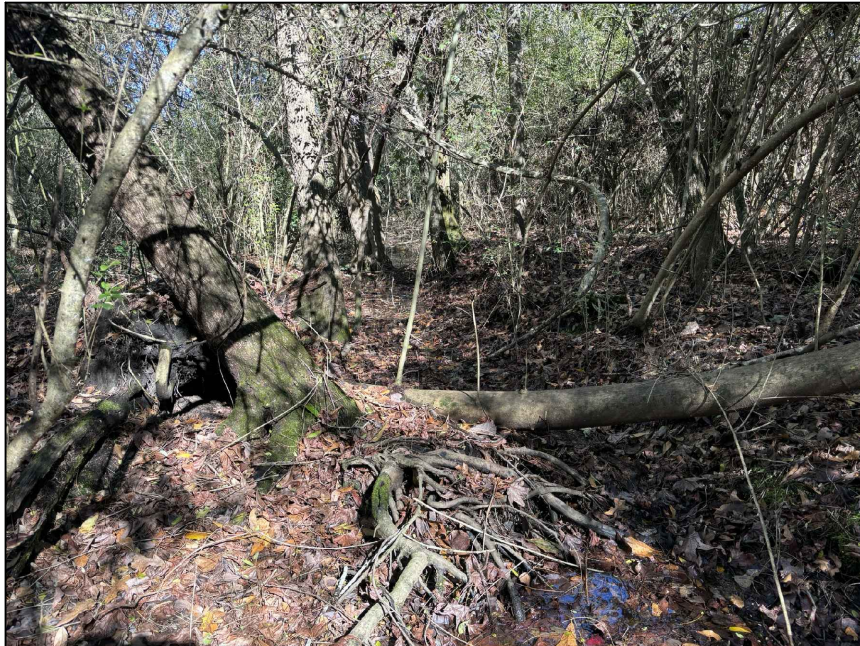
P-6

General view of the southern portion of W-1.

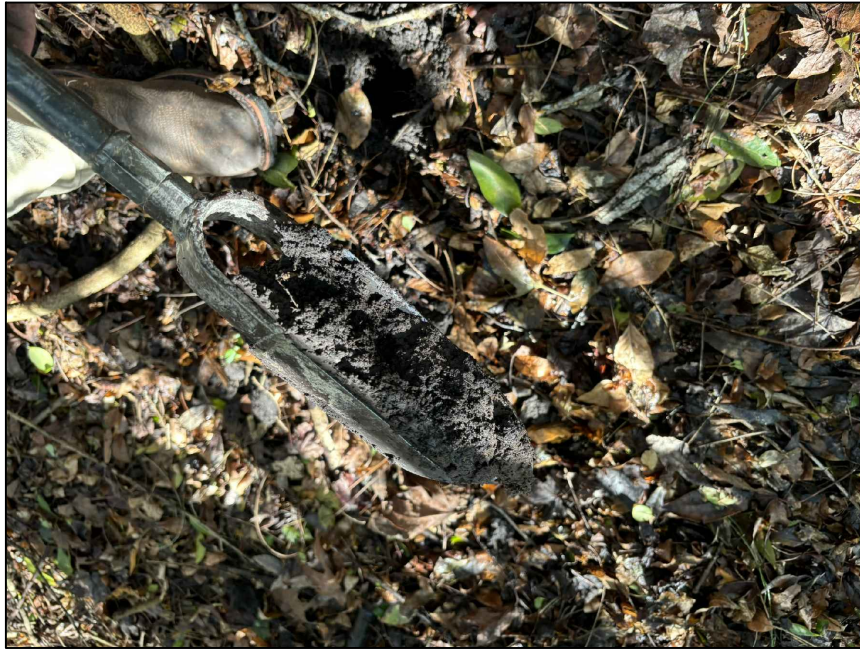
P-7

General view of representative soils within W-1.
